## 2006 Honda CR-V

VIN: JHLRD78506C216277

Inspection Date: July 25, 2026

Prepared By: MotorInspect

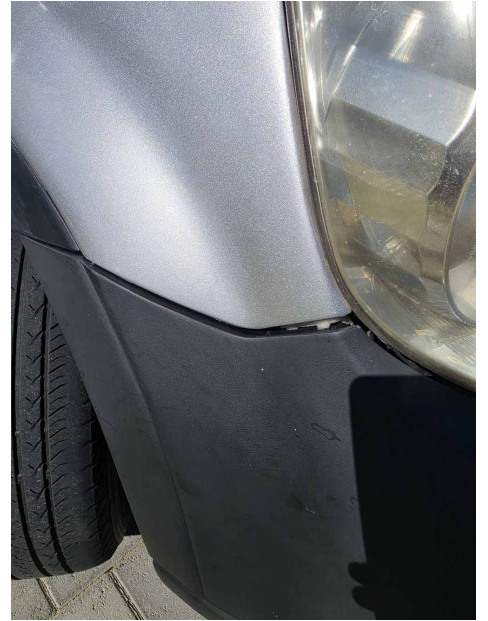
Front Bumper 2

| <input type="checkbox"/> | <input checked="" type="checkbox"/> | <input type="checkbox"/> | 3. Front Bumper - Misaligned |

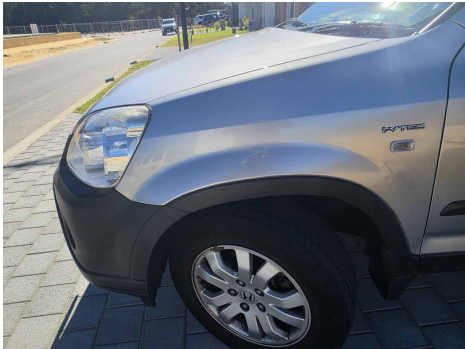
Left hand Fender

| <input type="checkbox"/> | <input checked="" type="checkbox"/> | <input type="checkbox"/> | 5. Left hand Doors - Dents, cracks or scratches present |

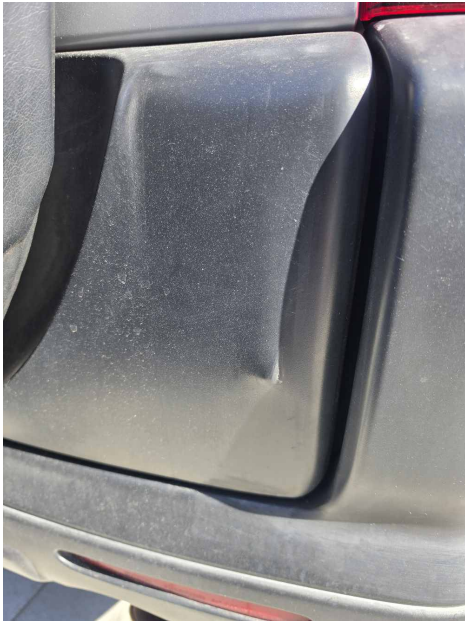
Rear Bumper 1

| <input type="checkbox"/> | <input checked="" type="checkbox"/> | <input type="checkbox"/> | 8. Rear Bumper - Dents, cracks or scratches present |

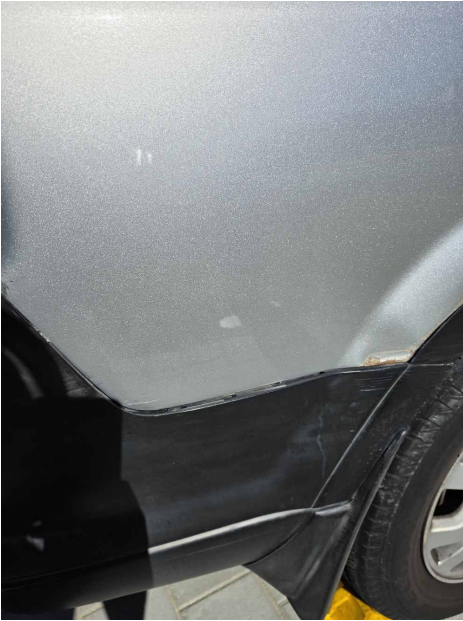
Right hand 3/4 panel 1

| <input type="checkbox"/> | <input type="checkbox"/> | <input checked="" type="checkbox"/> | 10. Right hand 3/4 panel - Has damage |

Right hand 3/4 panel - Has damage

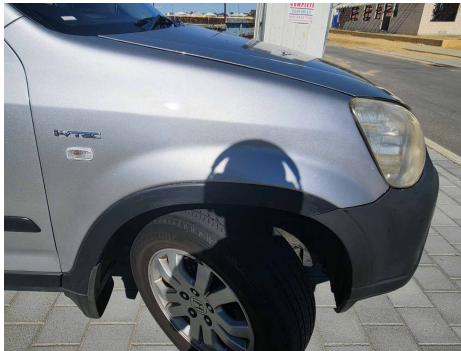
Paint thickness 1

| <input type="checkbox"/> | <input type="checkbox"/> | <input checked="" type="checkbox"/> | 17. Paint thickness - Using paint thickness gauge, paint thickness is not consistent on the body. Right hand side fender has more paint thickness. |

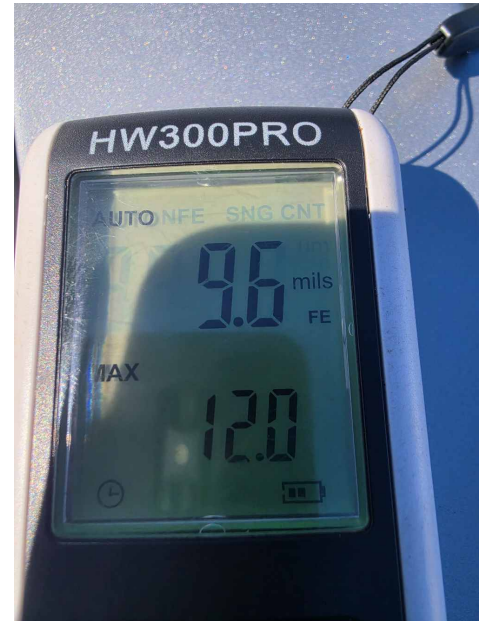
Paint thickness 2

Paint thickness - Using paint thickness gauge, paint thickness is not consistent on the body. Right hand side fender has more paint thickness.

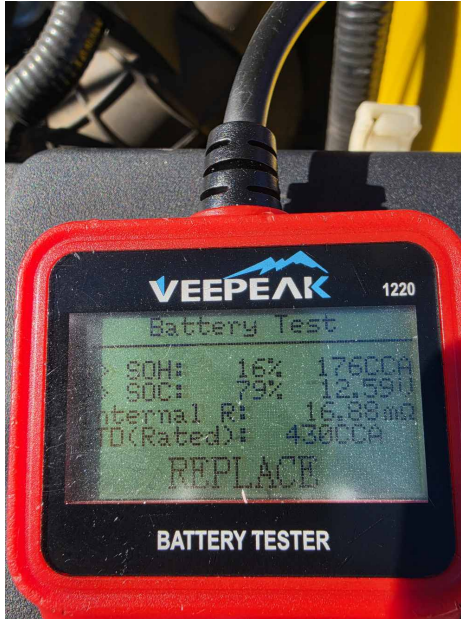
Battery 1

| G | F | P | |
|---|---|---|---|
| <input type="checkbox"/> | <input type="checkbox"/> | <input checked="" type="checkbox"/> | 19. Battery - Excessive corrosion present<br>Failed battery health test. Needs replacement. |

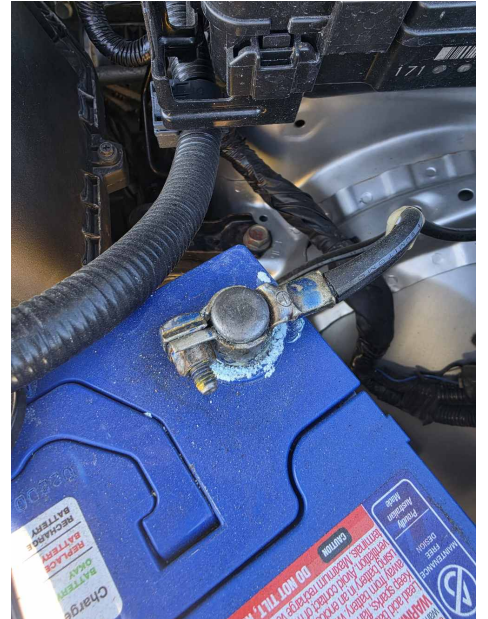
Battery 2

Battery - Excessive corrosion present

Failed battery health test. Needs replacement.

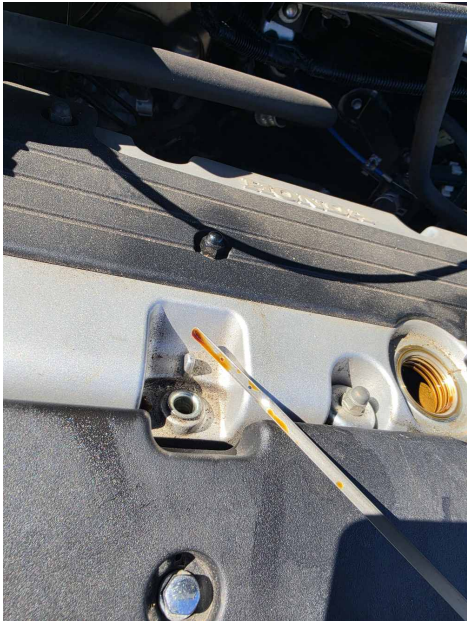
| G | F | P | |
|---|---|---|---|
| <input type="checkbox"/> | <input checked="" type="checkbox"/> | <input type="checkbox"/> | 22. Engine oil - Dirty looking oil |

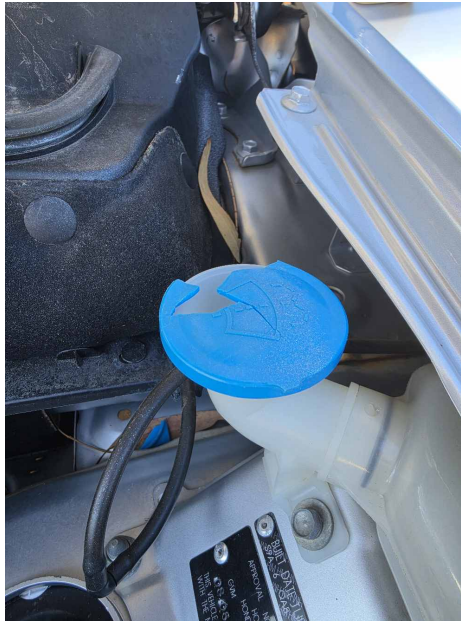
| G | F | P | |
|---|---|---|---|
| <input type="checkbox"/> | <input checked="" type="checkbox"/> | <input type="checkbox"/> | 25. Washer bottle fluid level - Low level<br>Bottle cap cracked |

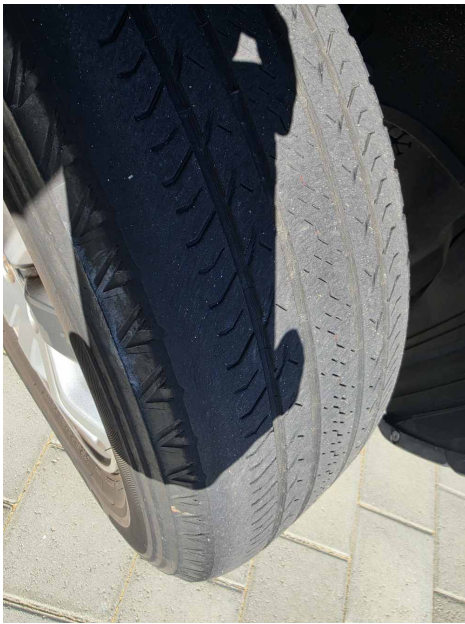
Condition of Tires 1

32. Condition of Tires - All tires need replaced,  
Sidewall damage,  
Wear indicates misalignment

Condition of Tyres - All tires need replaced,  
Sidewall damage,  
Wear indicates misalignment

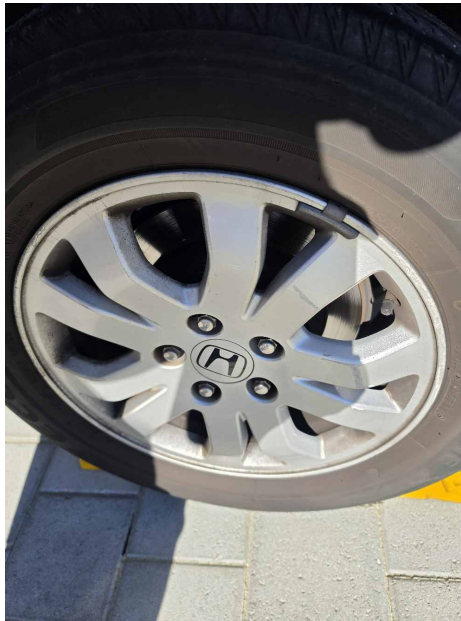
Condition of Wheels 1

33. Condition of Wheels - Scratches present

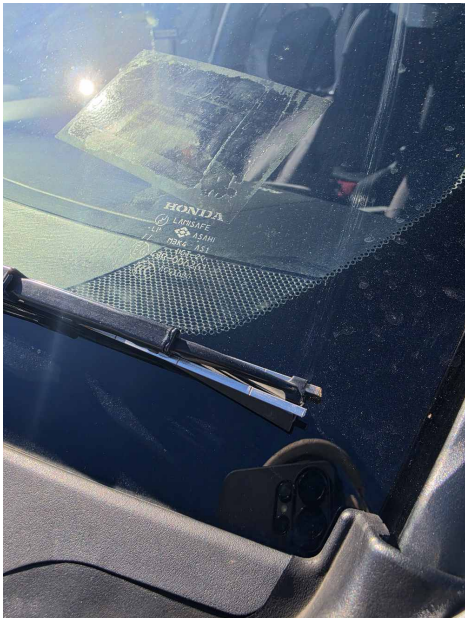
### Windscreen wipers

| G | F | P | |
|---|---|---|---|
| <input type="checkbox"/> | <input type="checkbox"/> | <input checked="" type="checkbox"/> | 61. Windscreen wipers - Worn |

Windscreen wipers - Worn

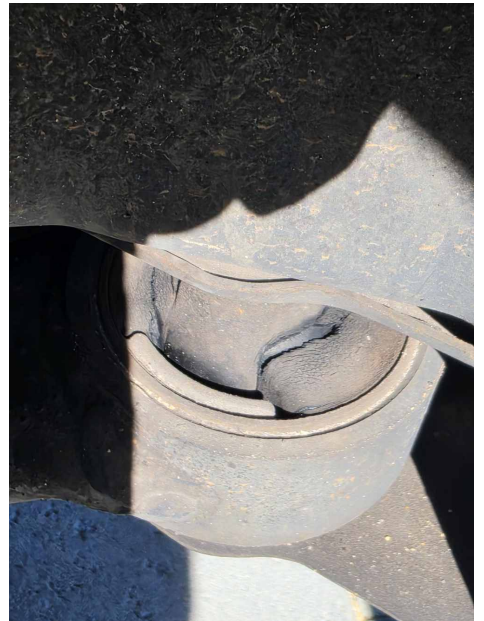
| G | F | P | |
|---|---|---|---|
| <input type="checkbox"/> | <input type="checkbox"/> | <input checked="" type="checkbox"/> | 73. Front suspension - Lower control arm bushes cracked. Need replacement |

Front suspension - Lower control arm bushes cracked. Need replacement
